Project Number H96423

PROJECT: Falcon Ridge (formerly  
Sunset Meadows Addition)  
Five Mile Prairie  
Spokane, WA

SUBJECT: Basements

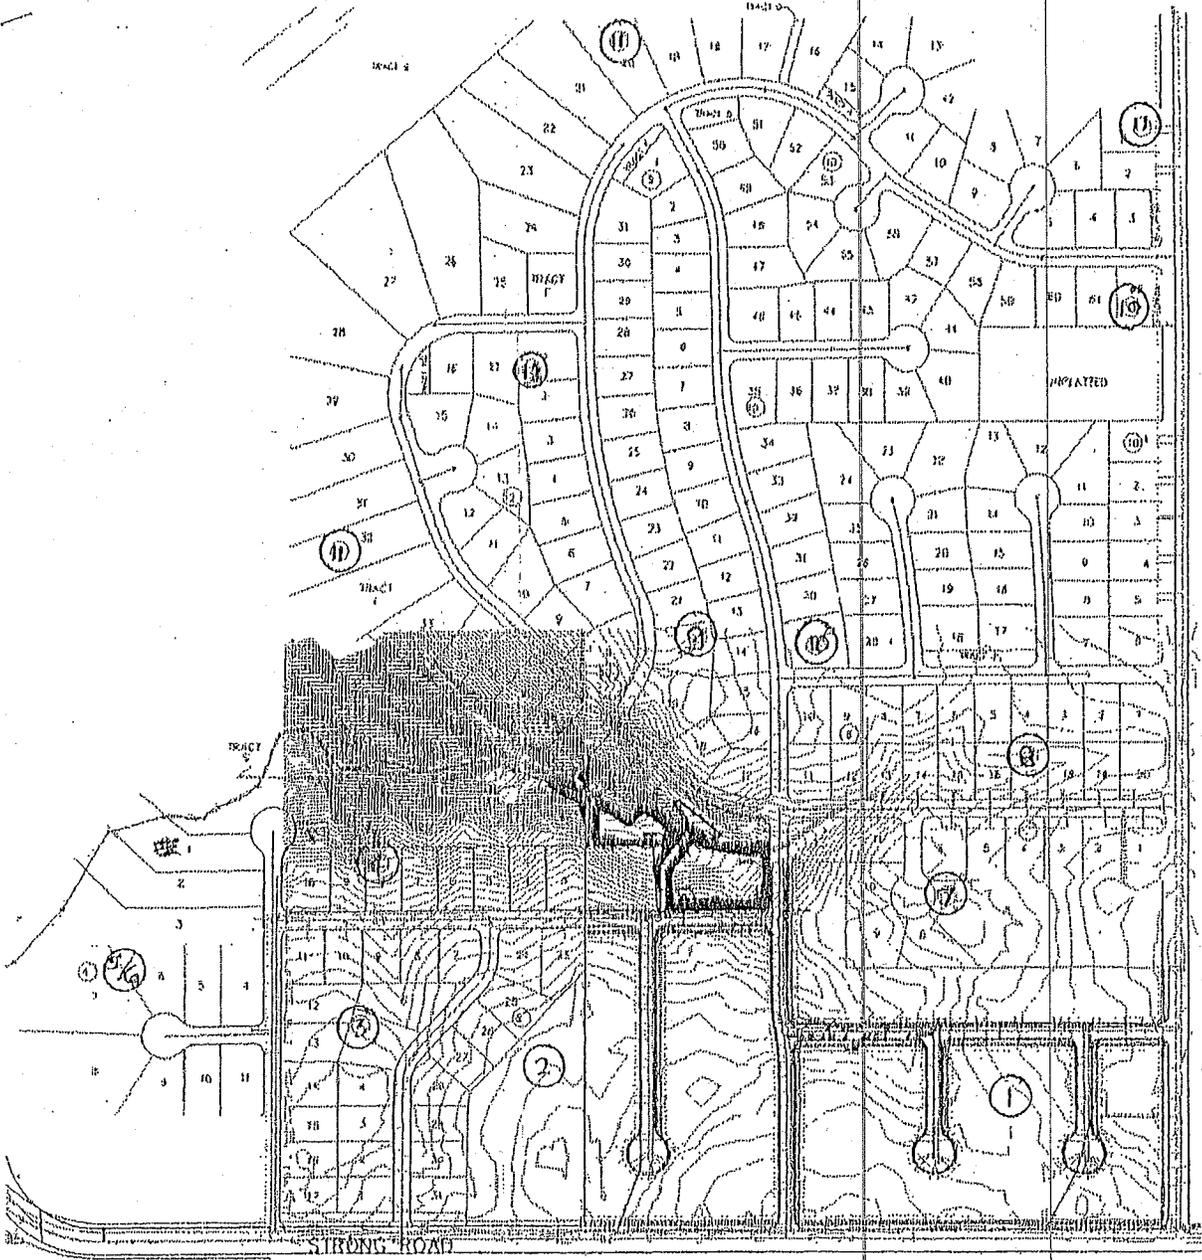
Figure 1

Block/Lot Layout

A summary by Block of anticipated conditions and suggested preliminary criteria for planning purposes is provided in Table 1, attached. The block and lot numbers correspond with plans by CLC Associates dated 7/31/01, except that we've labeled the 11 lots at the far west end "Block 5/6" due to apparently duplicated block numbers on that plan, as illustrated in Figure 1.
