**2007 Annual Water Quality Monitoring Report
Spokane Valley-Rathdrum Prairie Aquifer Long Term
Monitoring Program**

**Prepared by:
Spokane County Water Resources
Division of Utilities
1026 West Broadway Avenue
Spokane, Washington 99260**

February 15, 2008

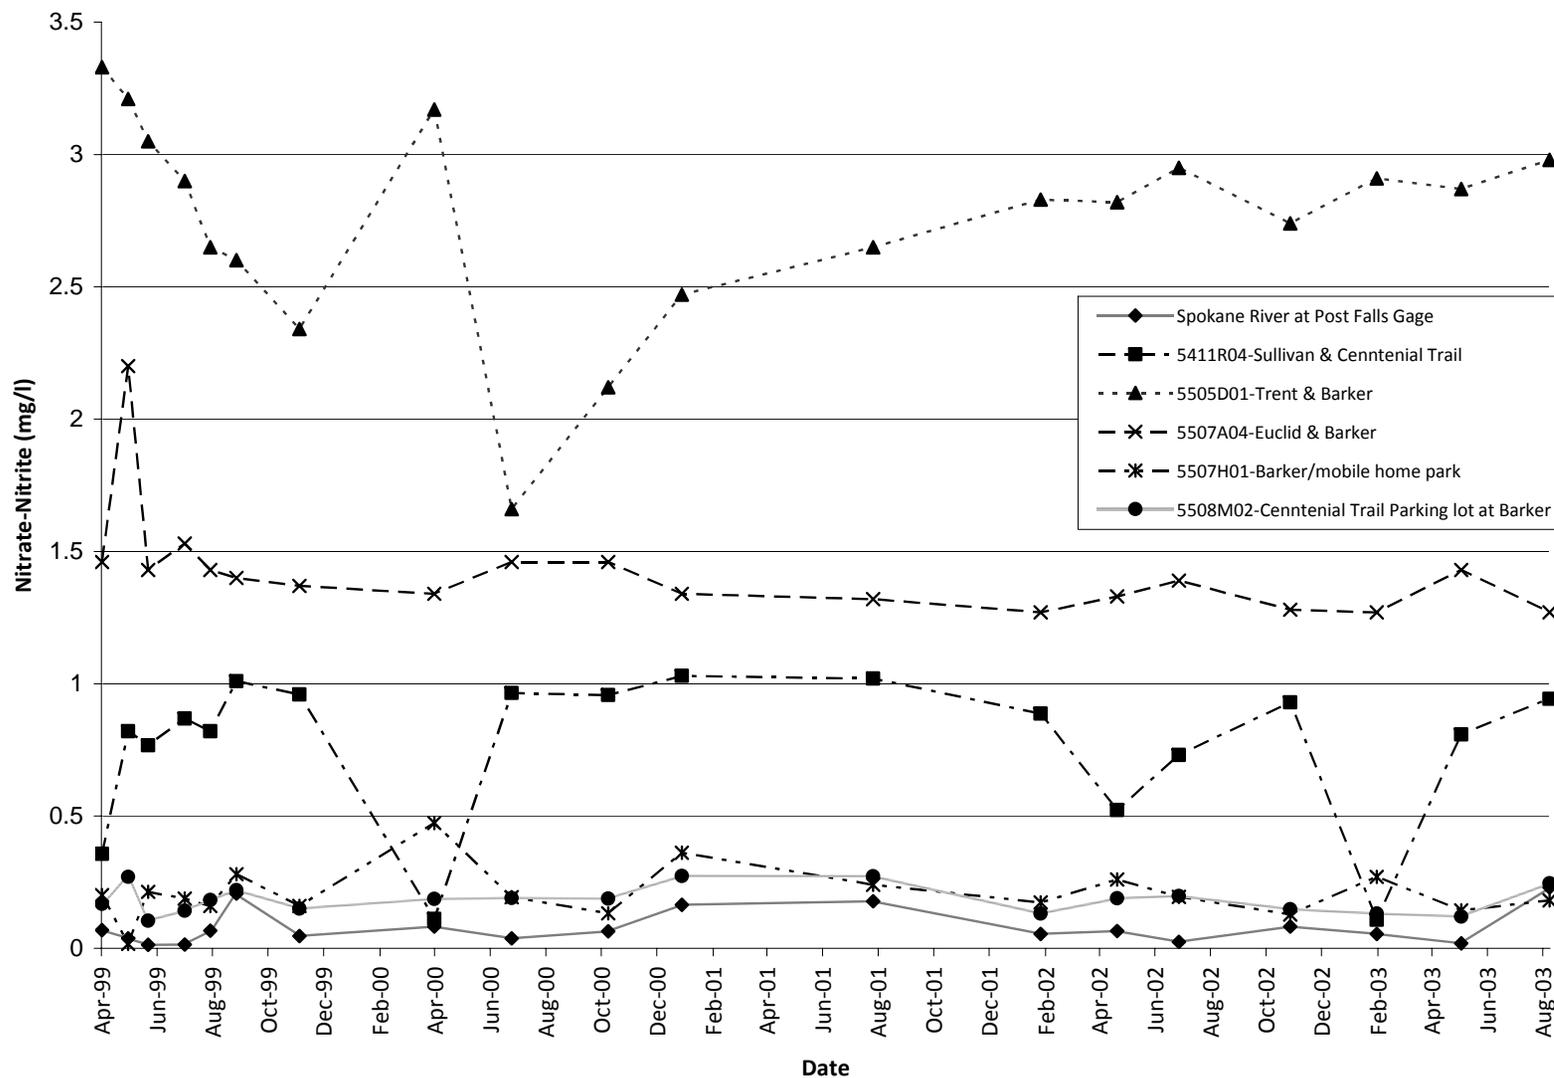
Figure 5: River/Aquifer Nitrate Concentration Correlation

- Wells 5508M01, 5508M02, and 5507H01, which are in close proximity to a losing reach of the Spokane River near Sullivan Park, do not show a trend. As shown in Figure 4-1 nitrate concentrations at these wells demonstrate a stronger correlation with river nitrate concentrations than nitrate concentrations throughout the aquifer.
